Check your Nuts—before they Bolt

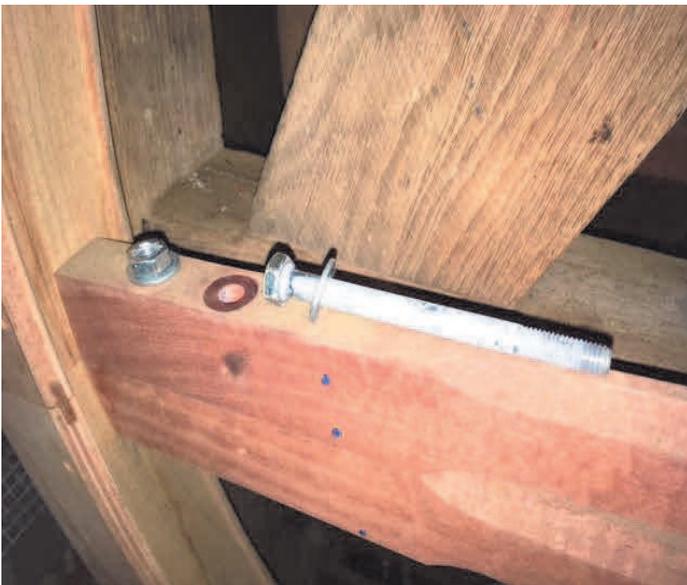
I was ringing the treble at Seal Chart on Sunday 12th August, for Sunday Service, when something fell on my shoulder, bounced on the floor, and then hit Annette MacKellar's foot - she was on the second. No, it wasn't a chip, but a five inch bolt, with two washers on the shank. There didn't appear to be anything wrong with the treble, so we rang the bells down, with a view to investigating the mystery later in the week.

Phil Jones and I did this the following Saturday, and Phil quickly found that one of the two bolts connecting the two halves of the wheel was missing (the halving or wheel bolts connect the two long rails of each half wheel), and the nut was in the pit. The photo shows the errant bits, placed either side of the hole where they should have been. Since the bells had been thoroughly checked only eight weeks before, on 12th June, we reckoned the prolonged hot spell had caused the wood to shrink, allowing the nut to work loose. Why there were two washers on the shank when it fell, and no washers, as far as we could see, in the pit, has not been satisfactorily answered. The odds of the washer at the nut end of the bolt both falling down two floors and ending up on the shank is highly improbable. But, then, if two washers had been put together at the other end when the bells were rehung ...?!

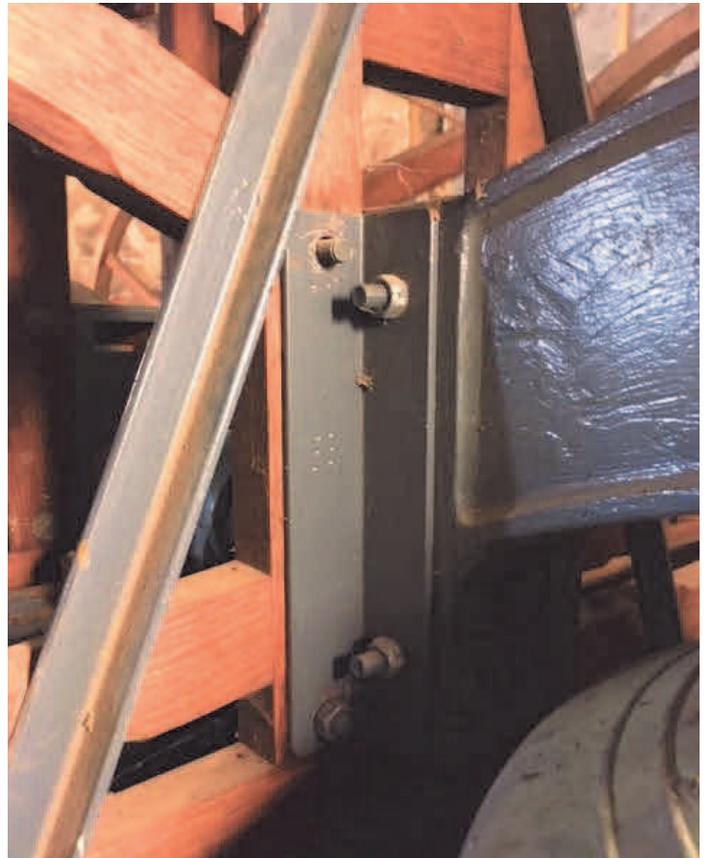
Stella and I looked on 7th September, and the situation was not as good as we would have expected. Quite a few of the wheel nuts were slightly loose (we would normally expect no more than one or two to be so), and most of the stays had one nut a little bit loose. More worryingly, on the sixth, where the headstock is attached to the wheel, one of the nuts was missing (see photo).

So, on a regular basis, and particularly after extreme hot or wet spells

USE YOUR NUT - CHECK YOUR BOLTS
